Report: XXXXX Drive Address:

Confidential Inspection Report

February 12, 2010

RE: XXXXXX Drive
Alpharetta, GA 30022

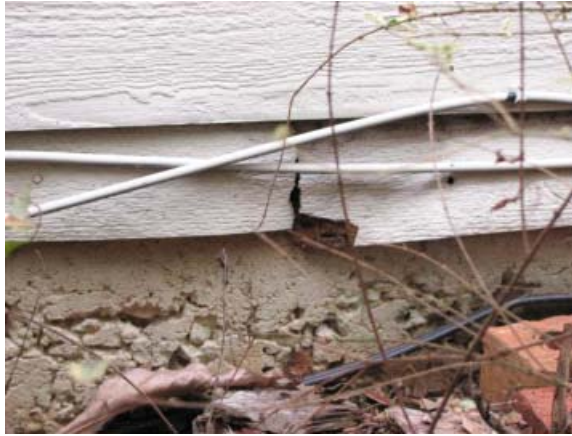
Decayed siding was observed on the bottom on the right side. It should be replaced.

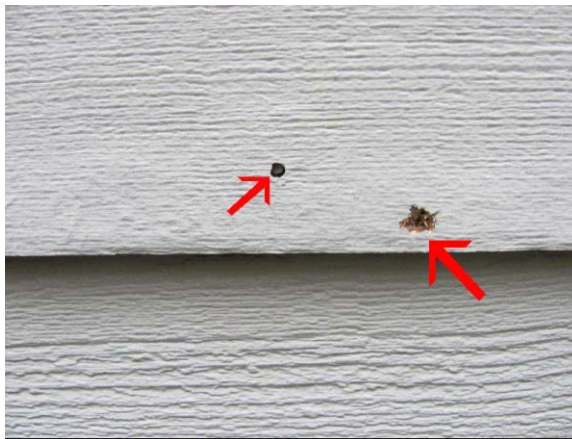
The siding on the right side is swollen due to water intrusion and several boards are soft and in need of replacement.

Swollen and soft siding right side

The siding on the right side and rear will eventually need to be replaced. In the meanwhile, the siding with recessed nails should be caulked and the siding painted.

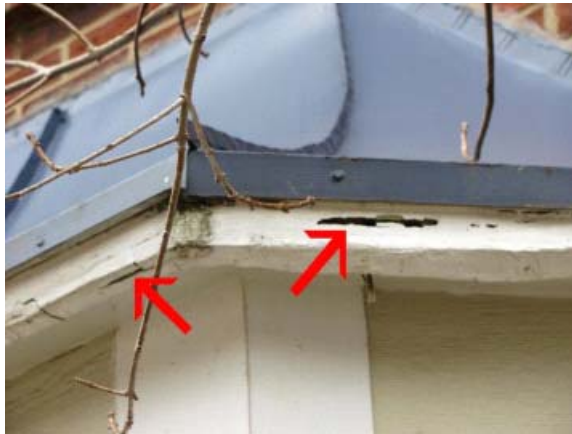
The fascia board on the front bay window below the metal roofing is decayed. It should be replaced.

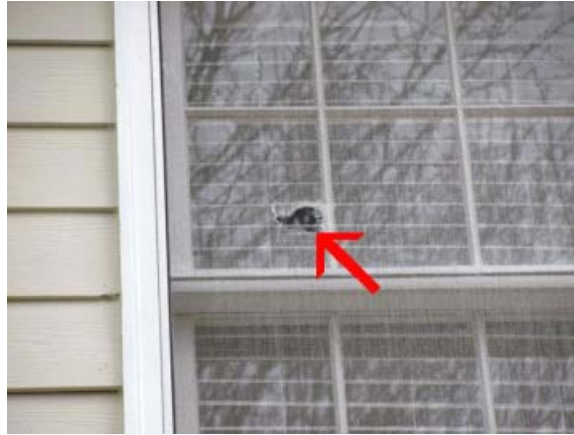
Several window screens are damaged and should be replaced.

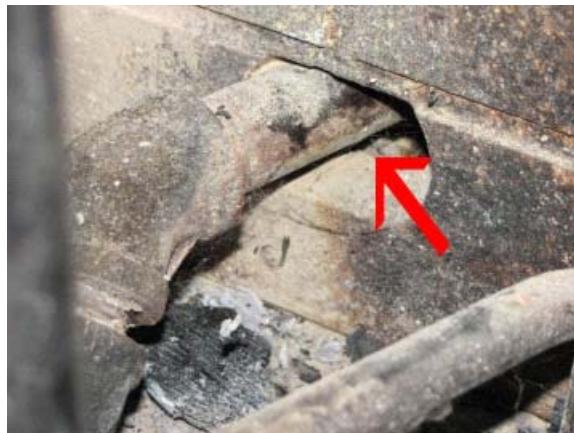
The gas pipe into the fireplace does not have high temperature sealant installed. This is needed for safety.

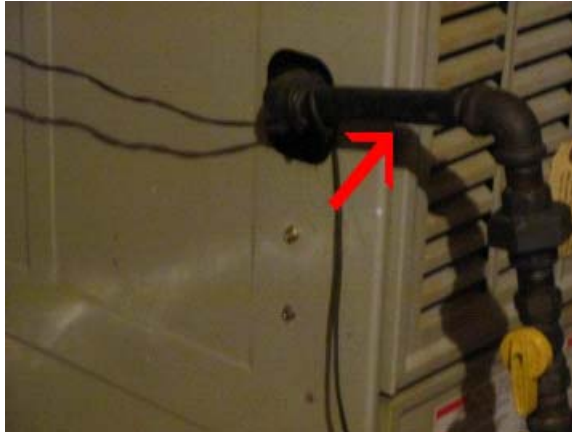
There is no sediment trap installed on the incoming gas line to the furnace in the attic. Installation of a sediment trap is required to prevent debris from entering into the gas valve.

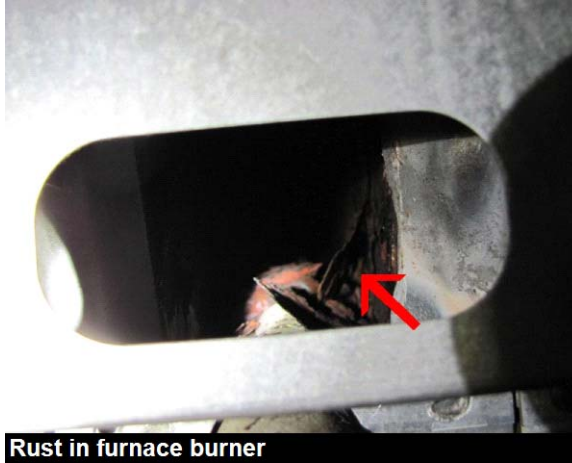
Rust was observed in the burner compartment of both furnaces. The furnaces should be serviced by a qualified HVAC contractor.

Rust in furnace burner

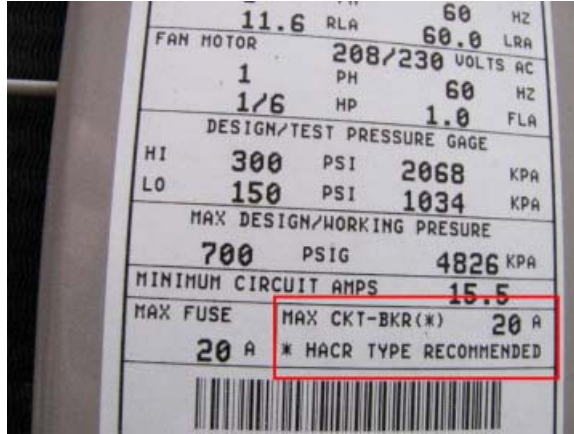
The breakers for the A/C units are oversized. The label on the units calls for a maximum size breaker of 20 amps. The installed breaker size is 30 amps for both units. The breakers should be changed for proper protection of the units.

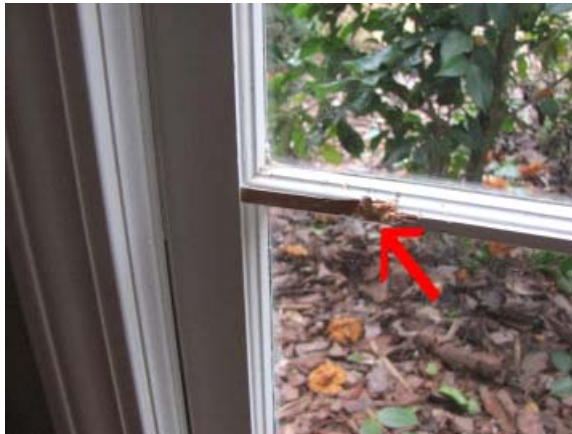
One of the windows is damaged near the bottom. Repair or replacement is needed.

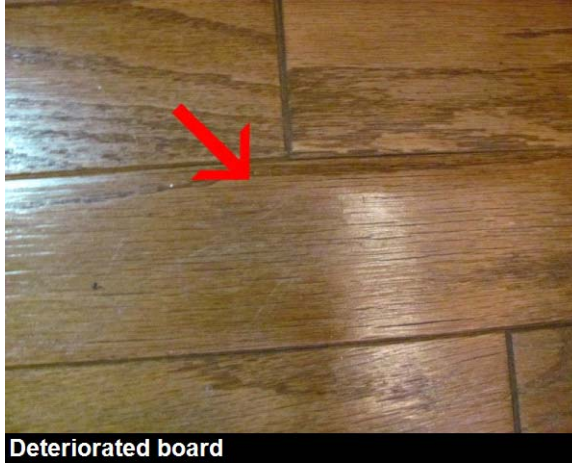
The hardwood flooring has deteriorated in the left rear corner. At least one board needs to be replaced.

Deteriorated board
