Confidential Inspection Report [XXXXXXXX]

Prepared for: [XXXXXXXX] [XXXXXXXX]

February 1, 2010

XXXXXXX Way
Covington, GA 30014

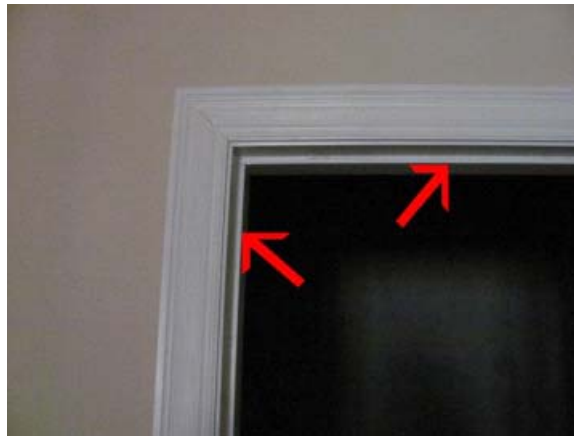
Interior Basement Doors:

The basement door between the heated area and unheated safe room does not have weatherstrip installed as required by the International Energy Conservation Code. Weatherstrip is required to be installed on sides, top and bottom.

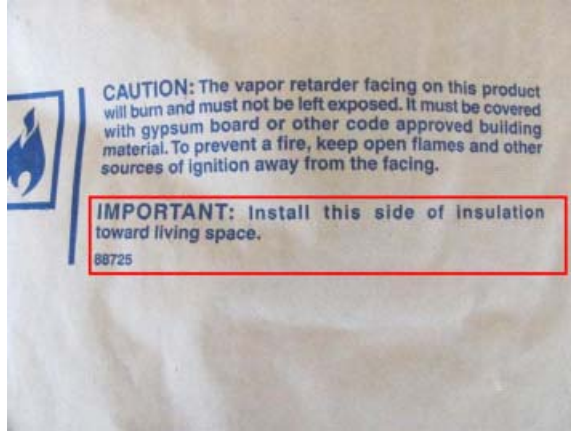
Basement Walls:

The wall insulation is installed backward with the vapor barrier facing the outside wall rather than facing the heated or living area as required in both unfinished areas of the basement.

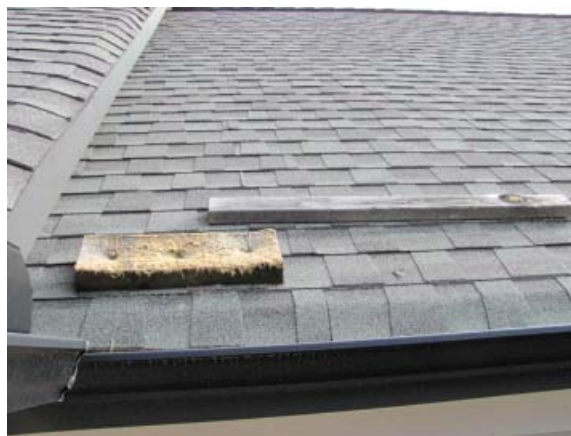
Condition of Roof Covering Material:

Two toe boards (boards nailed to roof by roofers) was observed on the front. They should be removed and the nail holes properly sealed.

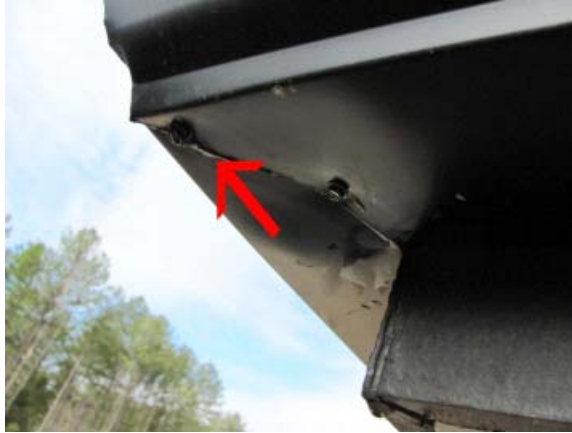
Roof Gutter System:

The gutter on the right upper level is leaking at the seam. Repairs should be made.

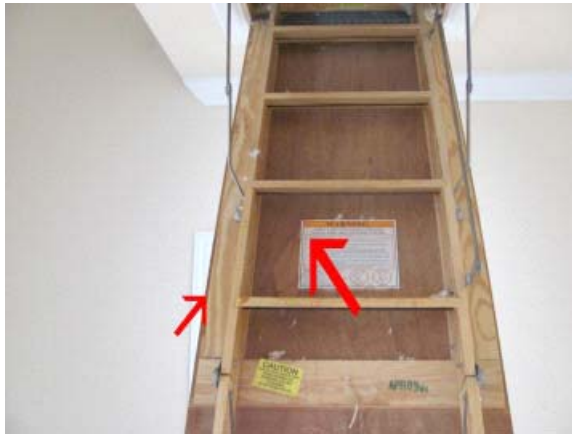
Attic Accessibility:

The pull-down stairs to the attic in the house is not insulated as required by the [International Energy Conservation Code](#) as amended by the [State of Georgia Appendix "Air Sealing Points"](#), which requires insulation with a minimum of "R-3 rating". Also, no weatherstrip is installed as required by the [International Energy Conservation Code Section 402.3.7](#) as amended by the state of Georgia which requires that "hatches, scuttle holes cover and disappearing/pull-down stairs

[must have factory applied or otherwise approved weather-strip".](#)

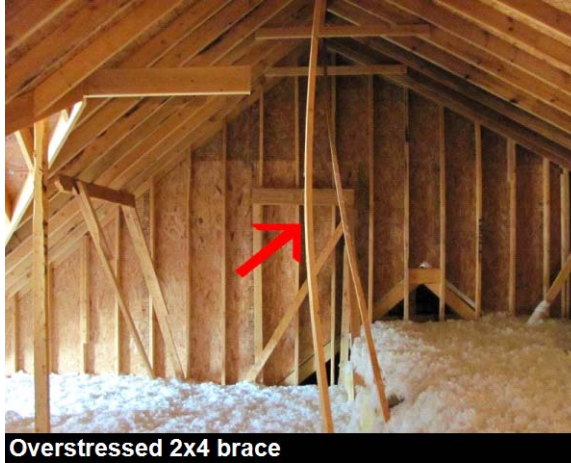
Roof Bracing:

A bowed roof brace was observed in the attic. The brace in question is a 2x4. It should be replaced with a 2x6 with a 2x4 or 2x6 nailed on the edge.

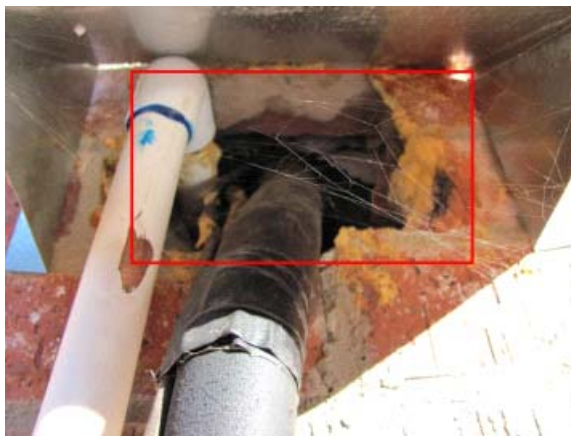
An opening was observed in the exterior wall on the right side at the A/C unit. This opening should be sealed according to The International Residential Code **M2301.2.7 Roof and wall penetrations**. Roof and wall penetrations shall be flashed and sealed to prevent entry of water, rodents and insects.

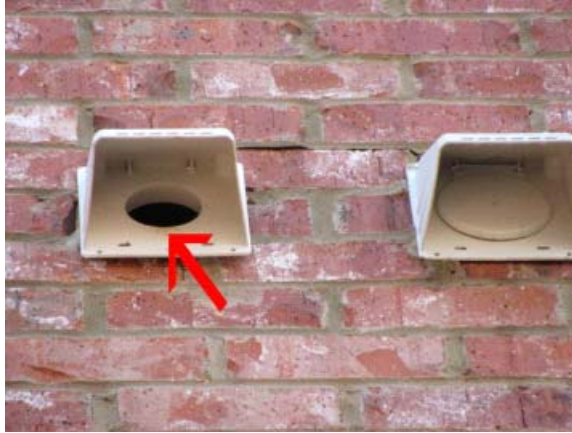
A bathroom vent on the left side is missing the flap. Repair is needed to prevent the entrance of vermin or insects.

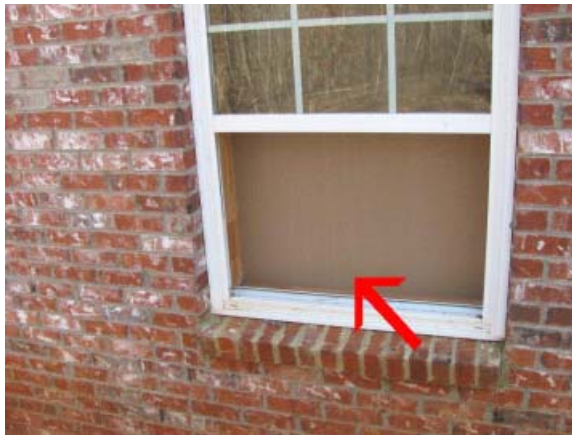
A missing window on the left side should be replaced.

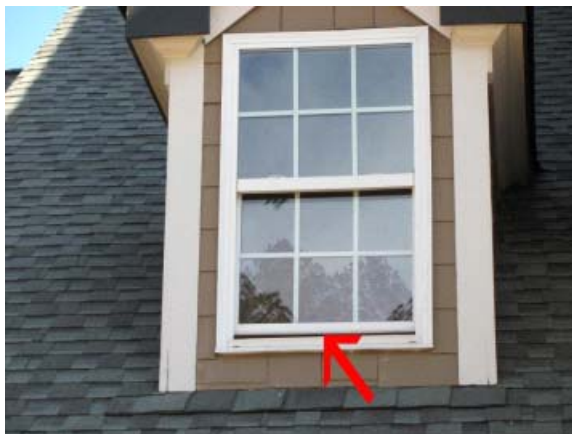
The window on the left side above the master close is partially open. This window cannot be accessed. This window should be closed.

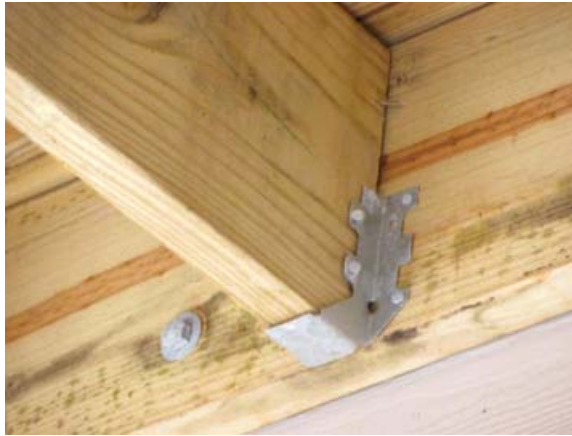
Framing of Deck/Porch/Balcony:

The joist hangers are too short. According to the hanger manufacturer's installation instruction, they should be at least 2/3 as long as the joist they are supporting. For this instance, the hangers should be app. 6 1/2 inches long.

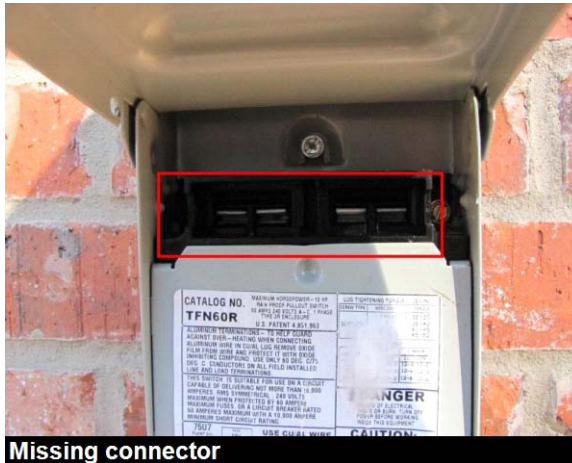
Service Disconnect & Wiring to Unit:

There is no connector installed in the service disconnect for the outside heat pumps for the main level and upper level. Therefore no power is available for the two units. The main level and the upper level are being heated by the backup heat strips only. These two units should be put into service by a qualified HVAC contractor.

Missing connector

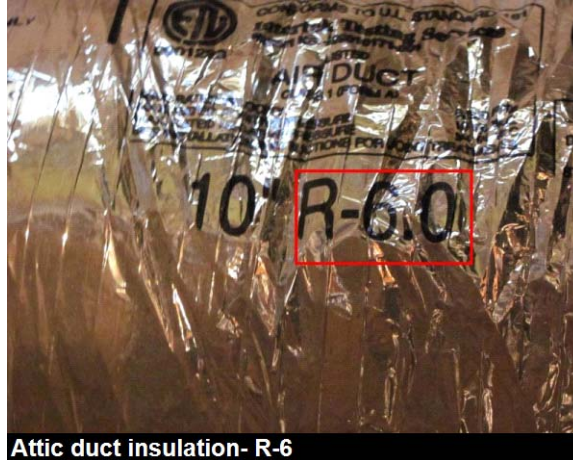
Duct Insulation Condition:

Ductwork in the attic is not R-8 as required since 1/1/2008 by the [International Energy Conservation Code](#) as amended by the State of Georgia 403.2.1 Insulation. Supply and return ducts in [unconditioned attics and exterior locations](#) shall be insulated to minimum of R-8. All other ducts located outside the building thermal envelope shall be insulated to a minimum of R-6. If the house was permitted after 1/1/2008, the duct insulation should be R-8 instead of R-6.

Attic duct insulation- R-6

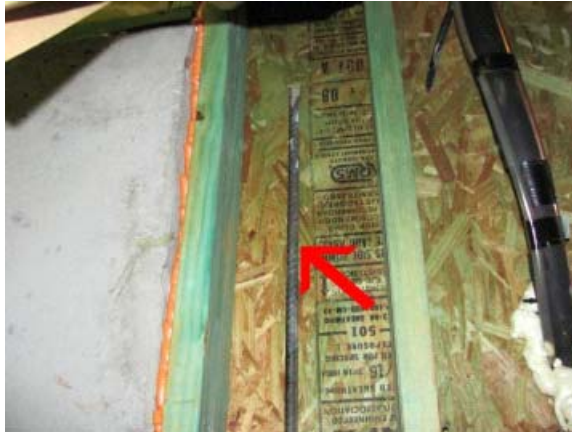
Main Service Ground/Other Systems Bonding:

The 2005 National Electric Code which was mandated in Georgia as of 1/1/2006 requires that all forms of grounding electrodes (means of grounding) that are present in a house must be used and must be bonded together. One of the forms is a "Concrete Encased Electrode". This is rebar that is in the basement wall of the house. The [National Electric Code states 250.50 Grounding Electrode System](#). All grounding electrodes as described in 250.52(A)(1) through (A)(6) [that are present at each building or structure served shall be bonded together to form the grounding electrode system](#).

Where none of these grounding electrodes exist, one or more of the grounding electrodes specified in 250.52(A)(4) through (A)(7) shall be installed and used." Number (A)3 is the Concrete Encased Electrode. The concrete encased electrode (rebar) was not used in this house as required. It is present in the basement but not used.

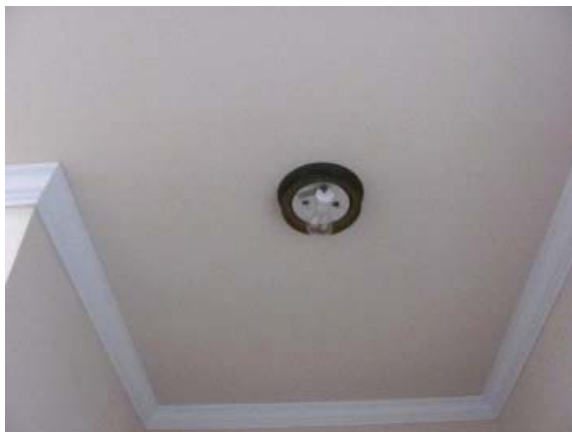
The light fixture is missing the cover in the basement hallway. It should be installed.

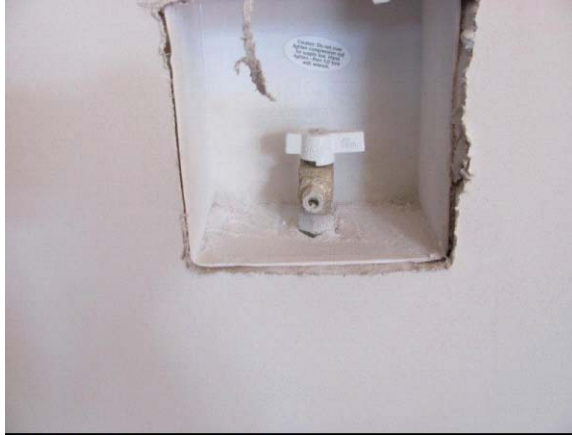
**Water Hammer Arrestors
Installed:**

No water hammer arrestors

No water hammer arrestors were found as required by the International Plumbing Code mandated by the State of Georgia effective 1/1/2007 "**604.9 Water hammer**. The flow velocity of the water distribution system shall be controlled to reduce the possibility of water hammer. A water-hammer arrestor shall be installed where quick-closing valves are utilized. Water-hammer arrestors shall be installed in accordance with the manufacturers specifications. Water-hammer arrestors shall conform to ASSE 1010. " Water

hammer arrestors should be installed at the ice maker valve, the dishwasher connection, and on the hot and cold water valves at the clothes washer. File photo inserted for reference.

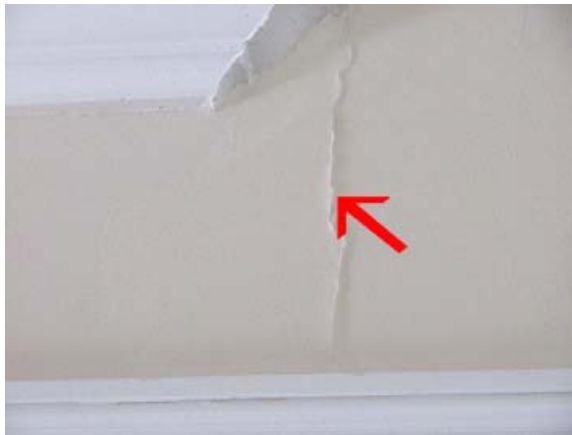
Walls:

A settlement crack was observed on the wall. Repair is needed.
