Report: XXXXX Drive Address:

## Confidential Inspection Report

February 12, 2010

RE: XXXXXX Drive  
Alpharetta, GA 30022

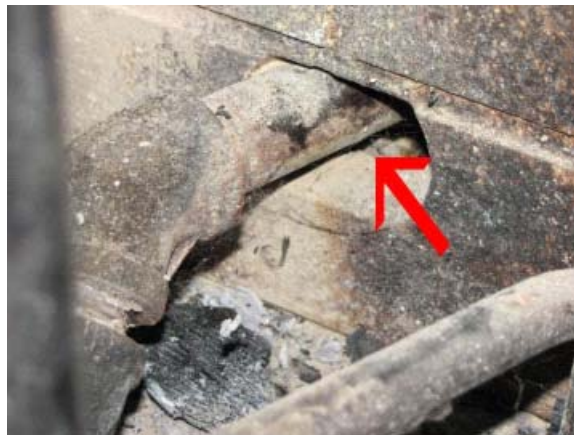
Fireplace Condition:

The gas pipe into the fireplace does not have high temperature sealant installed. This is needed for safety.

The gas pipe into the fireplace does not have high temperature sealant installed. This is needed for safety.

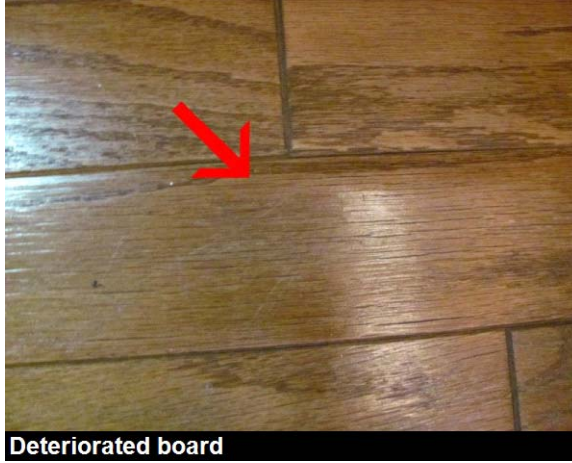
Floors:

The hardwood flooring has deteriorated in the left rear corner. At least one board needs to be replaced.

The hardwood flooring has deteriorated in the left rear corner. At least one board needs to be replaced.
