Confidential Inspection Report [XXXXXXXX]

Prepared for: [XXXXXXXX] [XXXXXXXX]

February 1, 2010

XXXXXXX Way
Covington, GA 30014

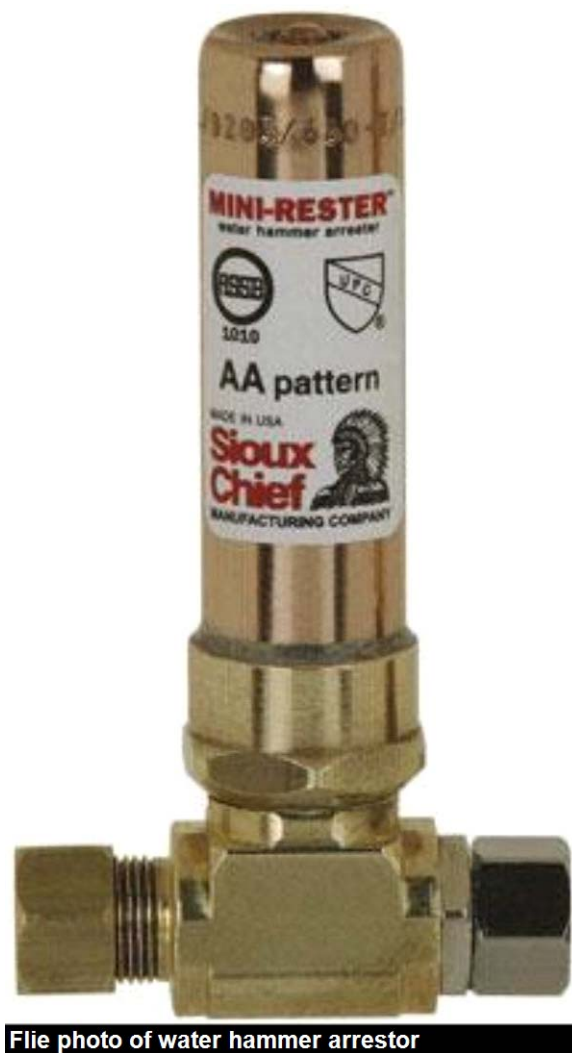
No water hammer arrestors were found as required by the International Plumbing Code mandated by the State of Georgia effective 1/1/2007 "**604.9 Water hammer**. The flow velocity of the water distribution system shall be controlled to reduce the possibility of water hammer. A water-hammer arrestor shall be installed where quick-closing valves are utilized. Water-hammer arrestors shall be installed in accordance with the manufacturers specifications. Water-hammer arrestors shall conform to ASSE 1010. " Water

File photo of water hammer arrestor

hammer arrestors should be installed at the ice maker valve, the dishwasher connection, and on the hot and cold water valves at the clothes washer. File photo inserted for reference.
